BEAVER RUN DAM  
NDI No. Pa. - 484

PHASE I INSPECTION REPORT  
NATIONAL DAM INSPECTION PROGRAM

Beaver Run Dam, NDI Number PA-484. Ohio River Basin, Beaver Run, Westmoreland County, Pennsylvania. Phase I Inspection Report.

11 May 1978 (visual inspection)

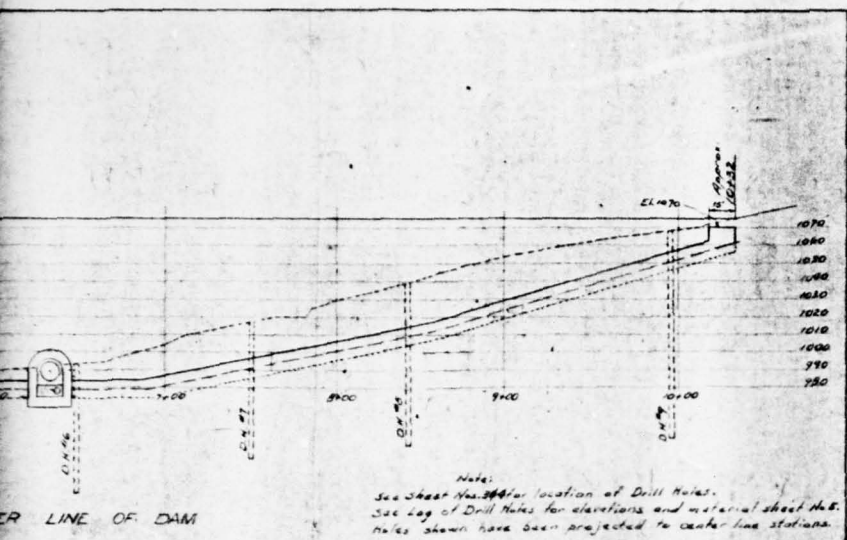
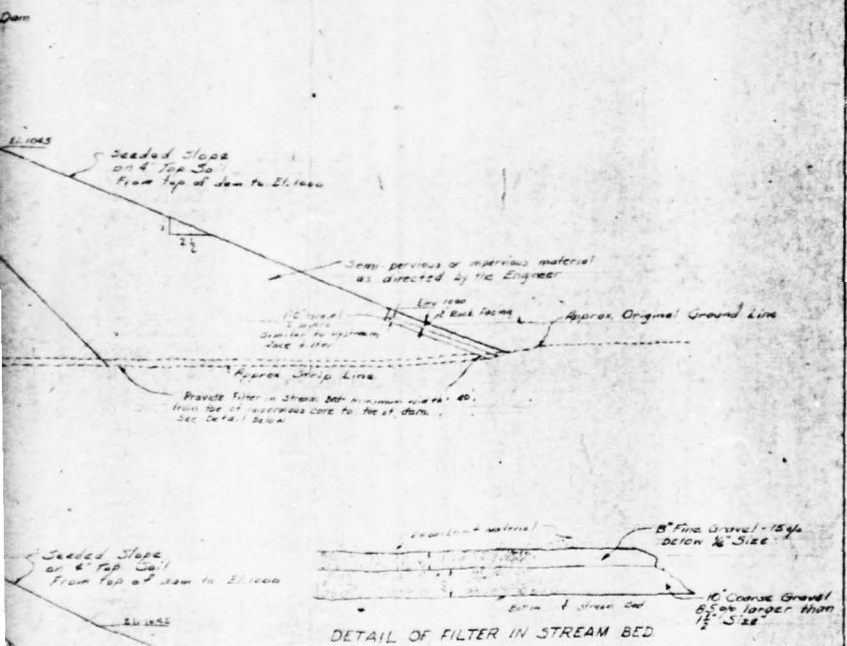
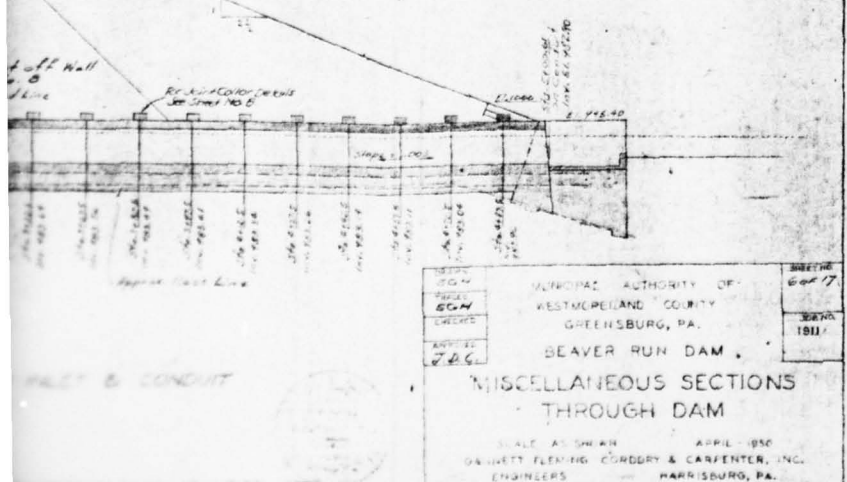
FIGURE 3 C-7558

The original design called for an earth embankment with a downstream rock zone (see Figure 3). Preliminary investigations failed to produce the quantity of material needed to construct the rockfill portion of the embankment and subsequently an earthen embankment was reportedly constructed (see Geology, Appendix E). The details of embankment construction are only inferred since as-built drawings are not available.

Zoning - (inferred from drawings and PennDER files) - Rolled earth with a riprap bedding on upstream face. According to the most recent pre-construction drawings, a 40-foot wide sand and gravel filter was installed in the old streambed (see Figure 3).
